Bureau of Mines Information Circular/1985

# Inverted Pyramid-Shaped Plugs for Closing Abandoned Mine Shafts—Galena, KS, Demonstration Project

Information Circular 8998

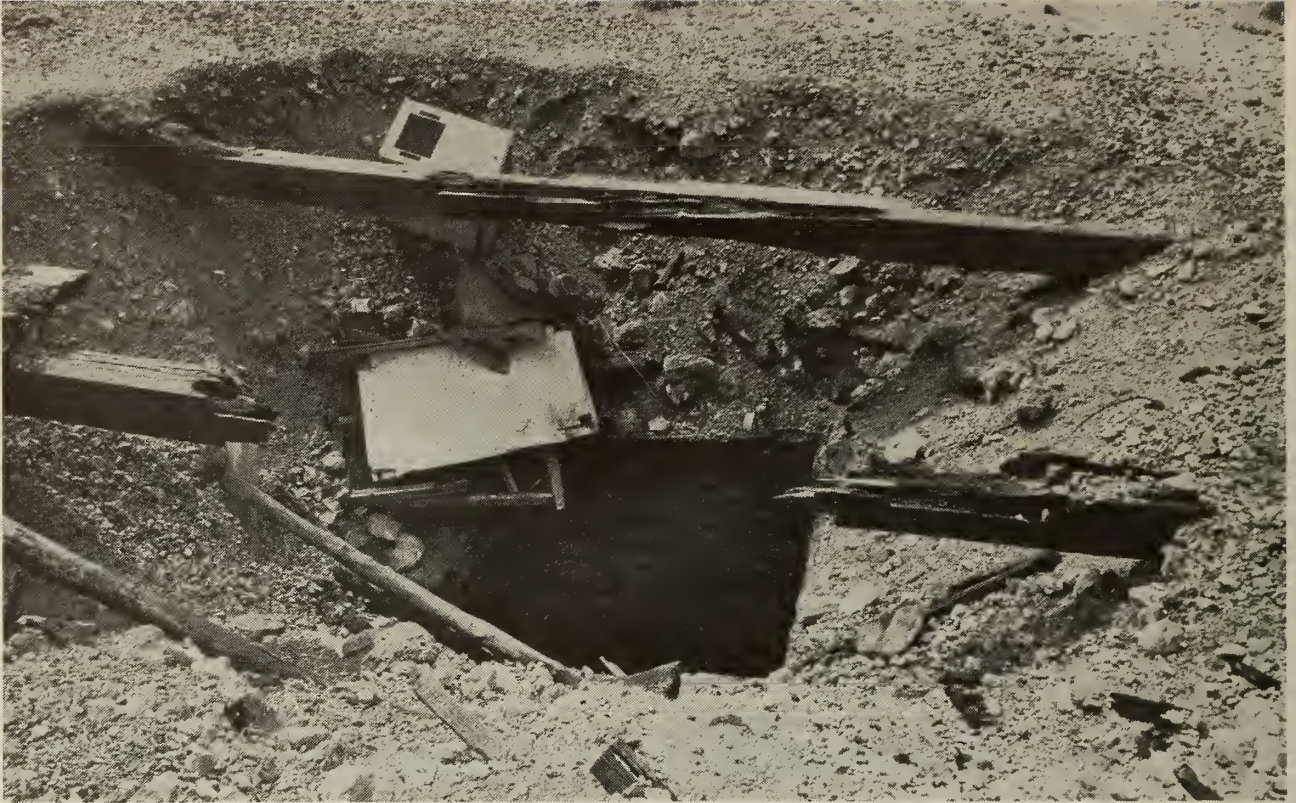
FIGURE 2. - Typical open shaft with timber still in place.

Four of the open shafts selected for plugging are shown in figures 2 through 5. Contract 50/34005 was let to Goodson and Associates, Inc., Denver, CO, in 1982 to obtain the shaft dimensions, assess the conditions of shaft side walls, and

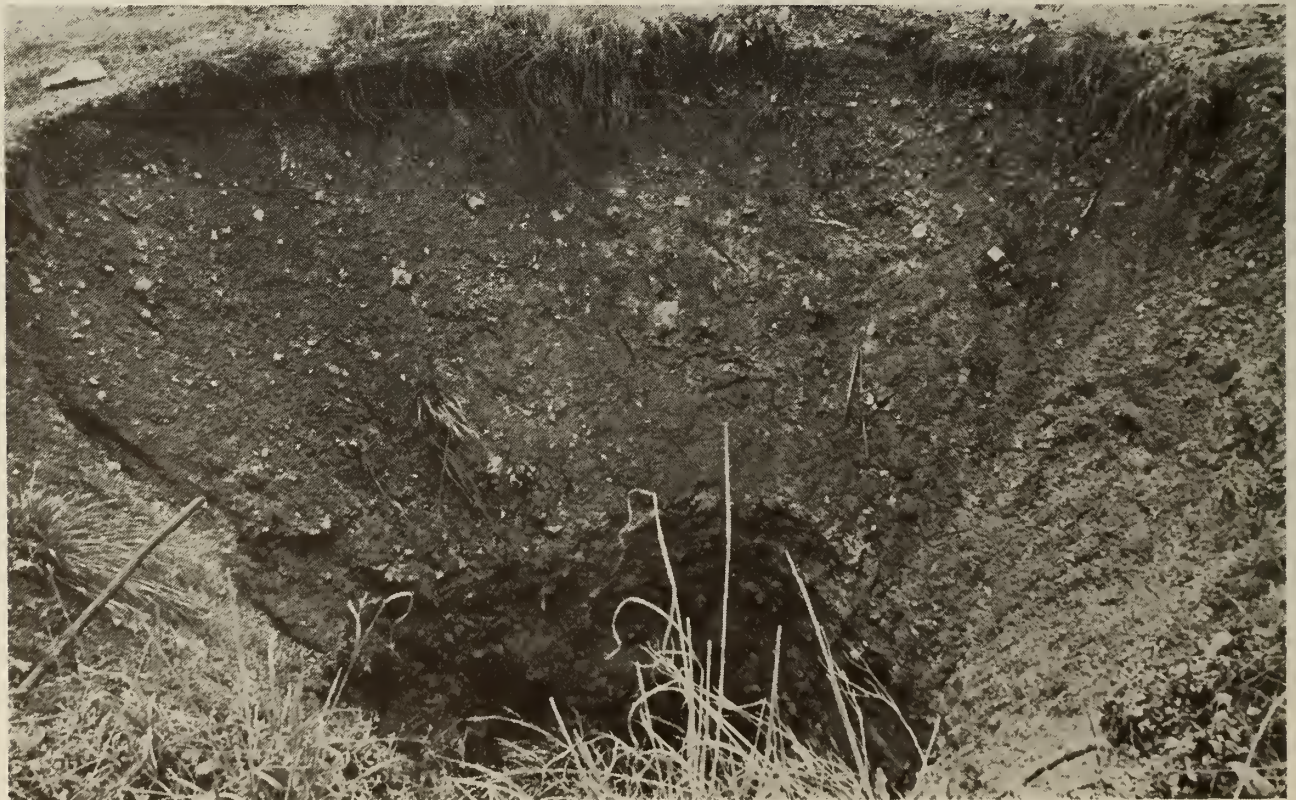
FIGURE 3. - Typical open shaft with enlarged surface opening.

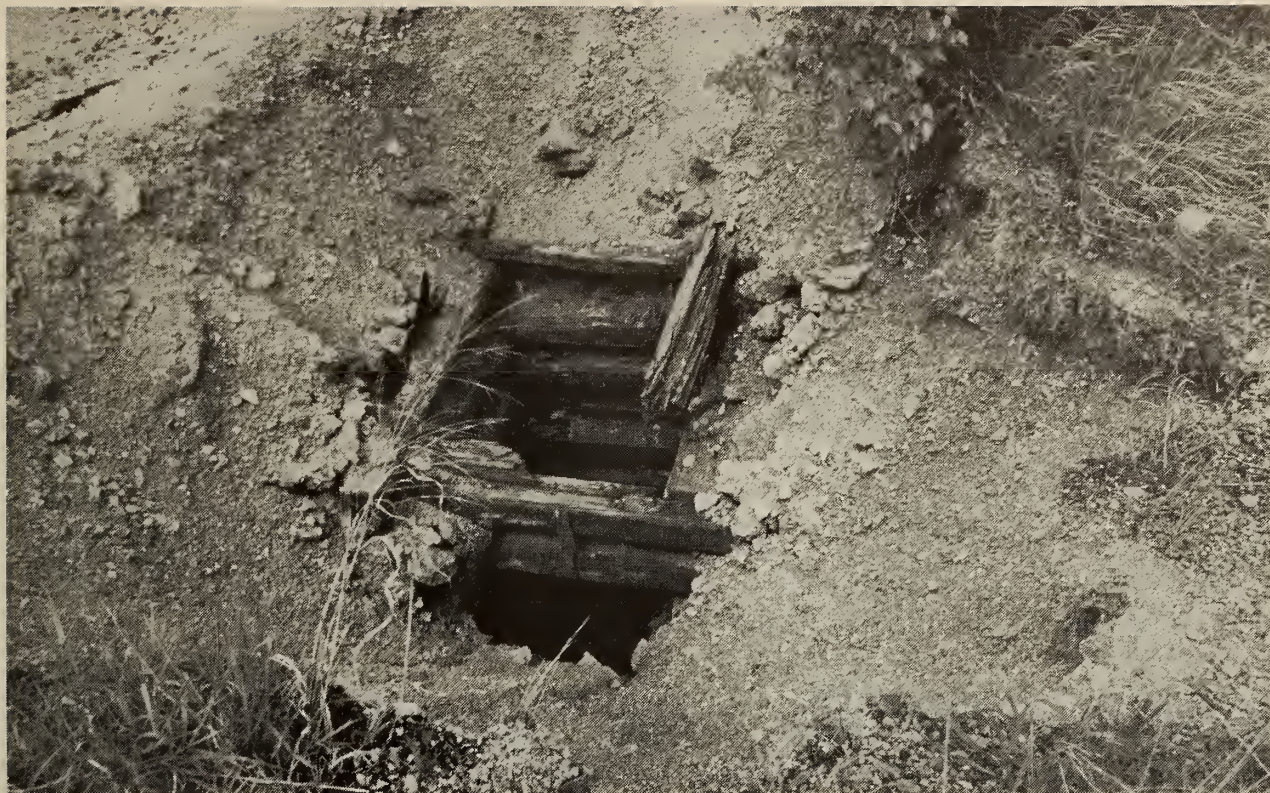
FIGURE 4. - Typical shaft showing rotted timber and washout along timbers.

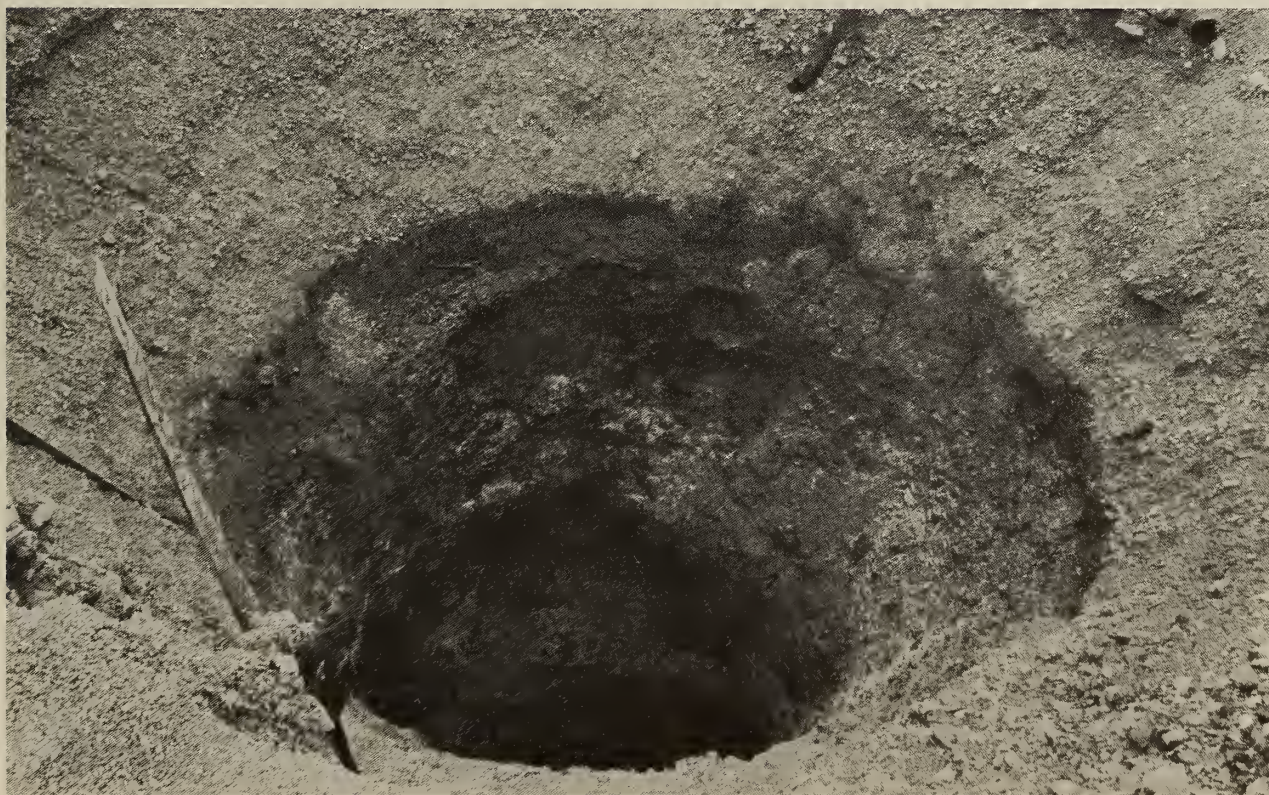
FIGURE 5. - Typical open shaft showing circular outline in slumping residuum.

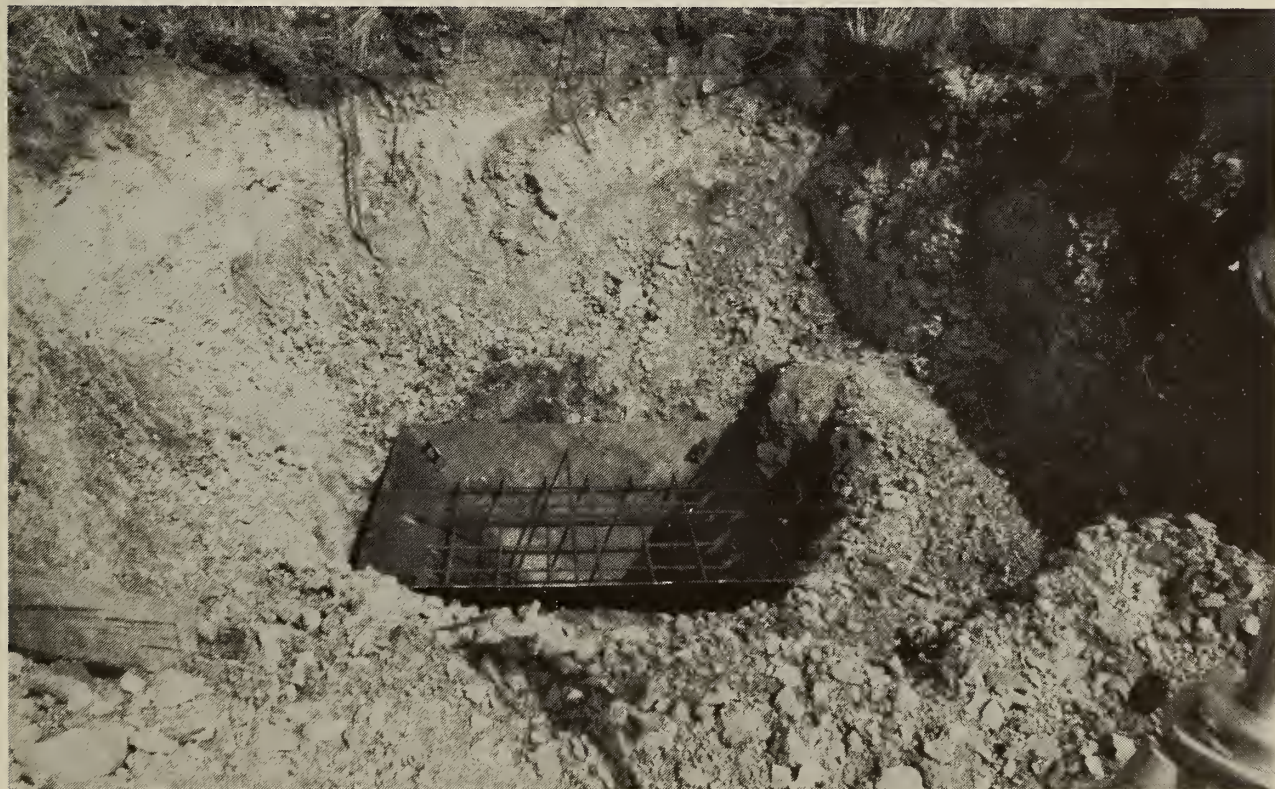
FIGURE 7. - 8-ft form showing reinforcing grid.

A horizontal reinforcing rod grid was placed 1 ft from the top in the 8-ft-square pyramid forms, 1.25 ft from the top in the 10-ft forms, and 1.5 ft from the top in the 12-ft forms. A 12-in grid spacing was used for both east-west and north-south positions (fig. 7). Grade 60, No. 7 reinforcing bars were used in each instance.

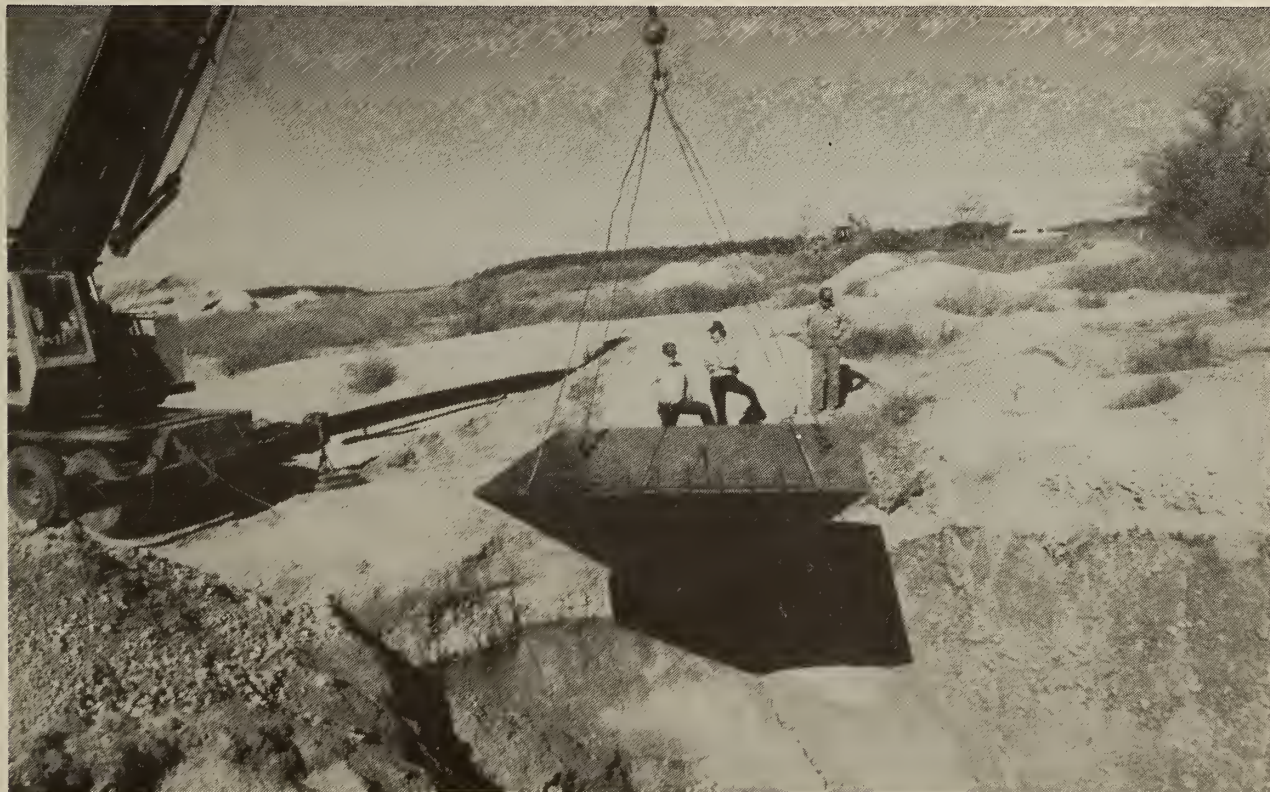
FIGURE 10. - Lowering form into opening.

The prefabricated forms were delivered to the site on a flatbed trailer and were unloaded from the truck and placed directly in the hole using a 17-ton crane (fig. 10). In several cases, additional sidewall trimming using the backhoe and/or jackhammer was required to obtain a level position for the forms.

The original specification required that cross-reinforcing bars be welded near the top of each form to be used for attaching cables for moving the forms. The fabricator preferred to weld a plate with an eye in each corner. Figure 10 shows this to be a preferable method and allowed for easy handling and positioning of the forms. The crossbars in the original design were omitted in the later-constructed forms.

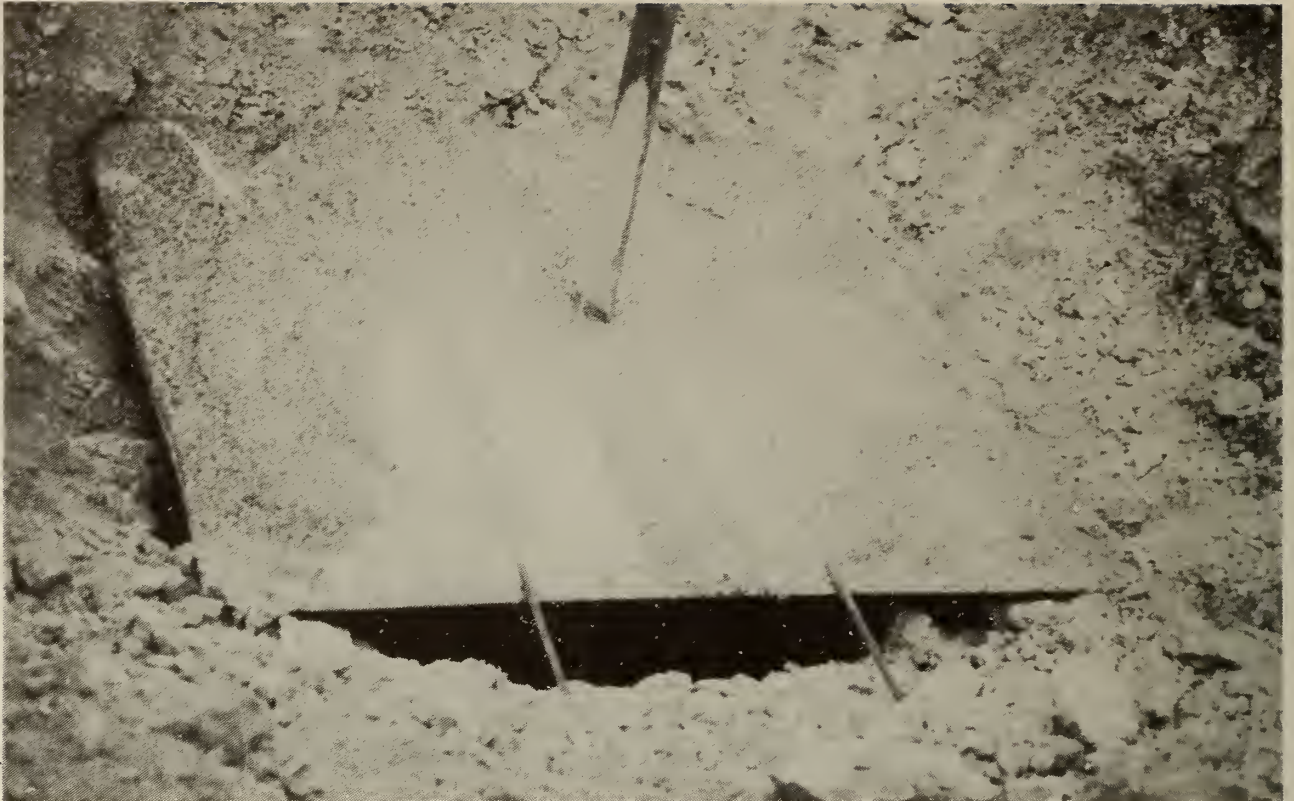
FIGURE 11. - Form filled with concrete showing space between form and shaft wall.

After the first three plugs were placed, it was noted that since the mine openings were only roughly square, there were noticeable gaps between the form and the sidewalls at some places (fig. 11). In these areas, reinforcing bars were positioned over the edge of the form and extended to the side of the prepared opening. This was covered with a 2-ft width of expanded metal, and 4 in of concrete was poured on this expanded metal (fig. 12). Figure 13 shows the same hole after the completion of the edge pour.

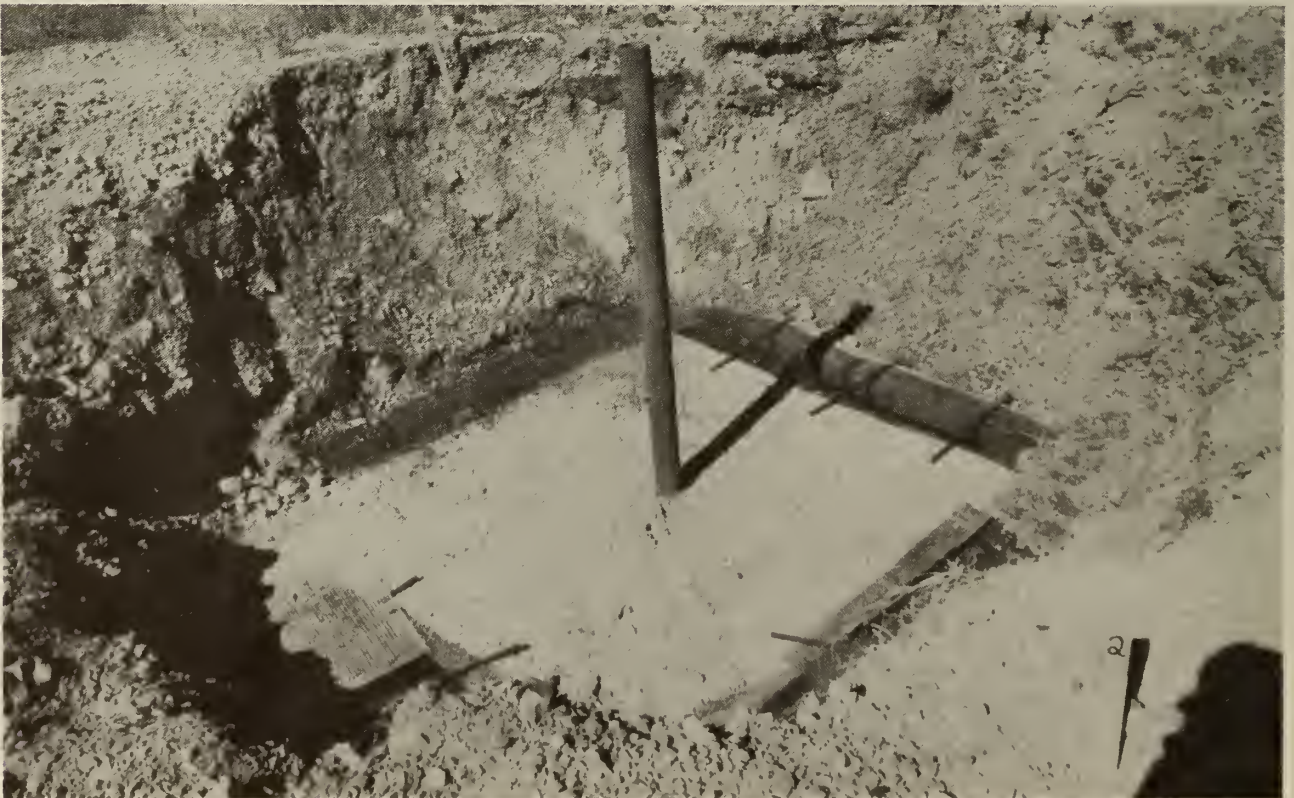
FIGURE 12. - Poured plug with expanded metal edging resting on reinforcing bars.

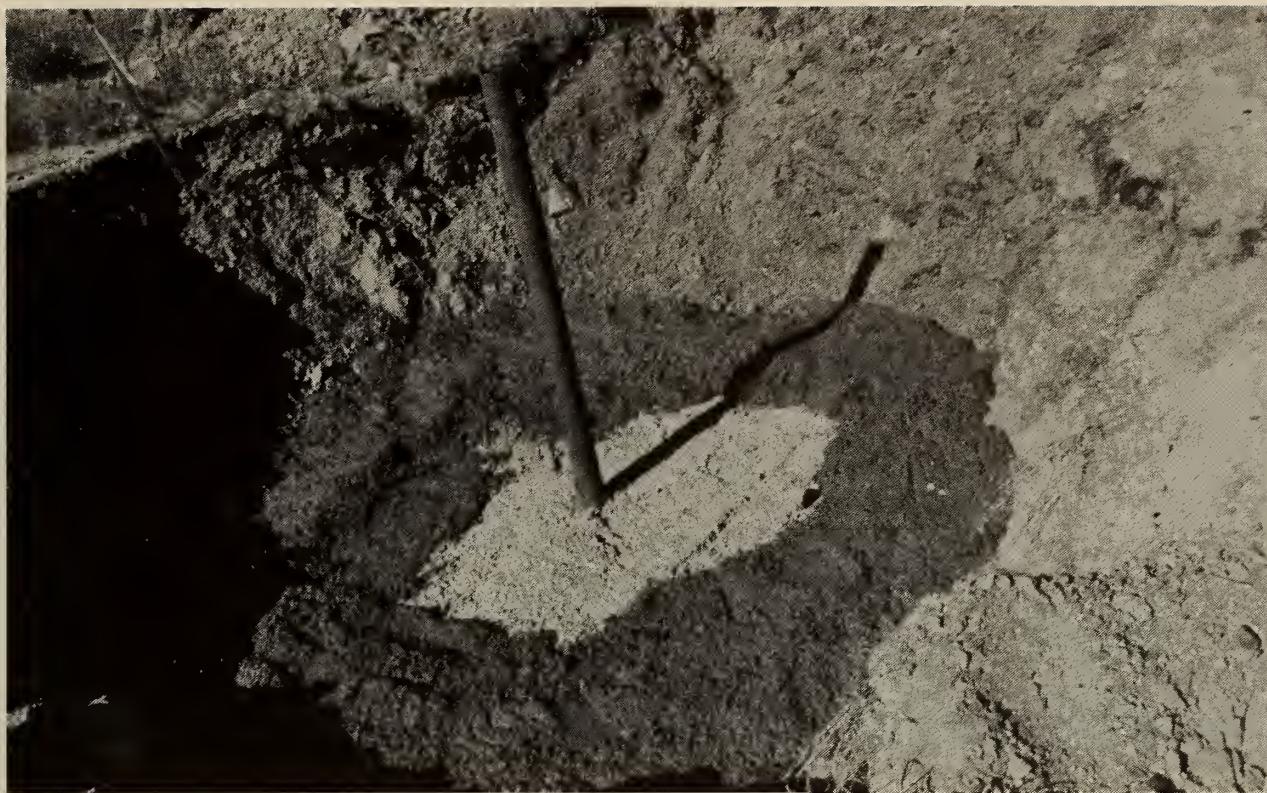
FIGURE 13. - New concrete poured on expanded metal surrounding plug.

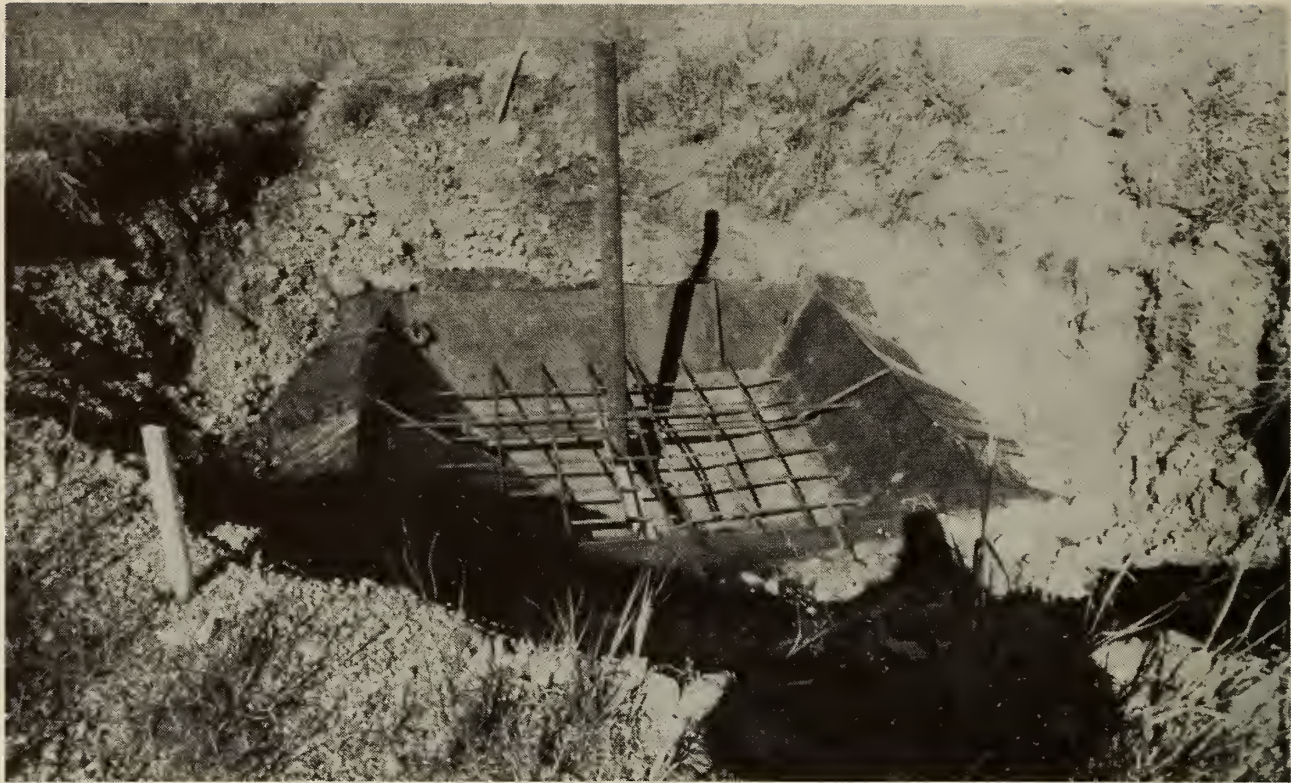
FIGURE 14. - 10-ft form showing spider-leg reinforcing over edge of form to support the expanded metal.

Before pouring concrete in the last eight forms, steel reinforcing rod was bent and fastened to the installed horizontal reinforcing grid and extended in spider-leg fashion several feet over the edge of the form. The 2-ft-wide expanded metal was positioned over these reinforcing rods, and concrete was poured over this when the form was filled. Figure 14 shows the positioning of the spider legs and expanded metal.
